LDEF IMPACT CRATERS FORMED BY CARBON-RICH IMPACTORS:
A PRELIMINARY REPORT

Two impact craters found in Al from LDEF experiment tray A11E00F have residues concentrated in the bottoms, along the walls, and on the top of overturned rims. Analyses indicate a "chondritic" compositional signature (Si, S, Ca, Fe, Mg, and Ni) for the bulk residue. In one crater (# 74) round to irregular silicate grains (crystalline in appearance) are overlain by carbon. In addition, carbon also partially covers the crater walls, the top of the raised/overturned rim and extends outwards from the crater. The second crater (# 31) also contains carbon with similiar distribution in and about the crater, although the silicate residue appears to be glassy. Silver, I, K and F (possibly some of the Ca, S, and Cl) appear to be contaminants as well as analyzed aromatic carbonaceous species associated with the raised rim and the area surrounding the crater. The origin of the impactors is assumed to be extraterrestrial. The existence of impactor residue in the two craters implies impact velocities of ≤ 6 km based on experimental hypervelocity impact studies.

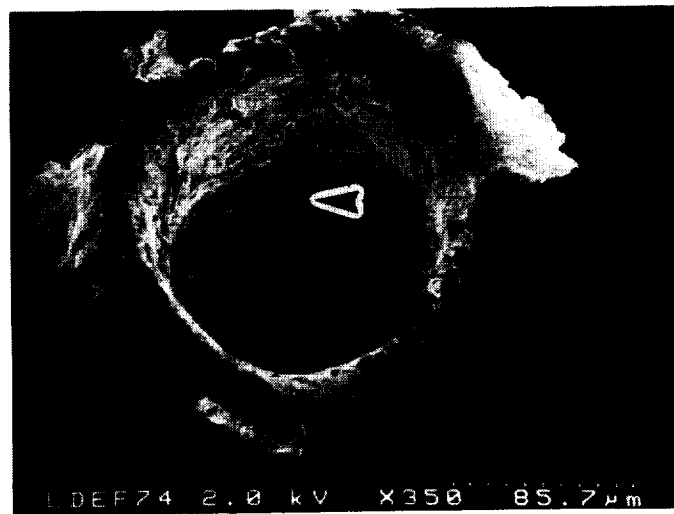
Figure 1. (a) FESEM BSE (backscattered electron) image of crater #74. Arrow points to round residual grain which is used as a reference in other figures. Fractures in Al that radiate away from the crater (NW direction), probably resulted from ductile/brittle fracturing during uplifting of the rim. Carbonaceous material (dark; curved arrow) is shown on the top of the overturned, raised rim. (b) Same crater as in (a) (slightly tilted and rotated 180°). FESEM BSE image. Note partially intact residual impactor in the crater bottom. 10 division scale is given in microns in the lower right corner of all FESEM images.

Crater #74 is 119 micrometers in diameter, measured from the points in the crater walls where the plane of the unraised surface intersects the crater (not measured from points on the raised rim walls). The depth/diameter ratio is 0.59 consistent with the average value of 0.6 for other LDEF craters (ref. 1). Figure 1 shows vertical and slightly tilted views of the crater. Impactor residue is concentrated in the bottom with impact melt "splash" lining the crater walls. The overturned raised rim shows irregular

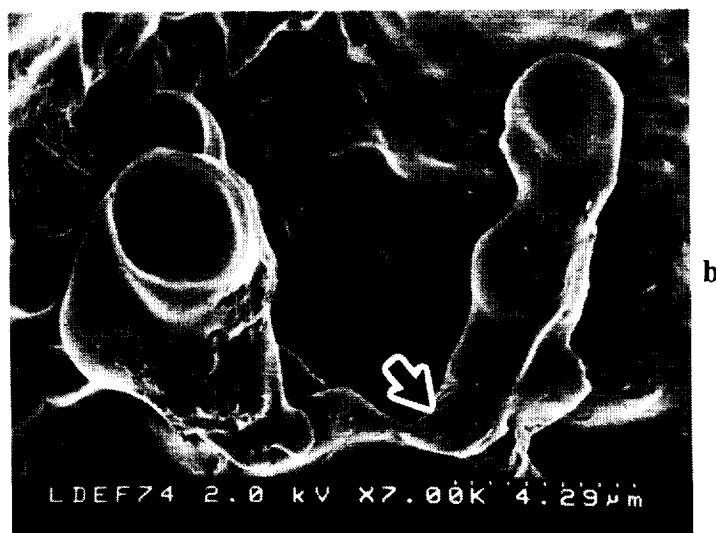
Figure 3. (a) Melt splash on the wall of crater #74. (b) Partially melted impactor grains that are coated with glass. Arrow points to twisted, pinched glass. (FESEM BSE image).

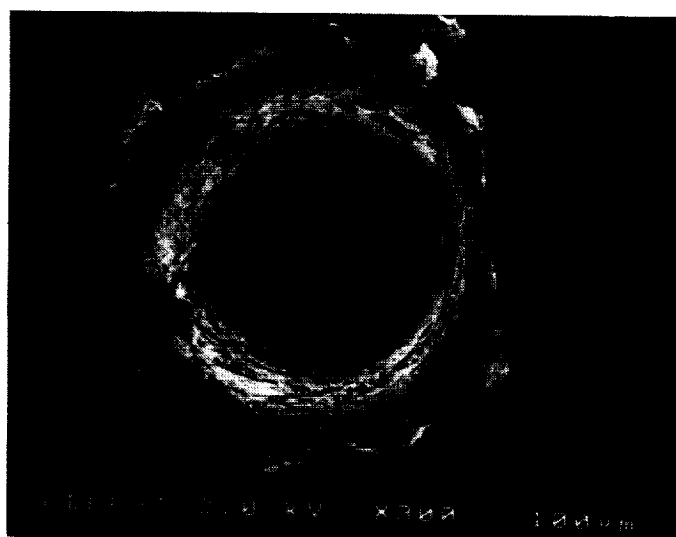
Figure 5. Crater #31. Impactor residue is probably all glass. (FESEM BSE image).

This crater is 158 μm in diameter with a depth/diameter ratio of 0.8. Whereas crater #74 contains partially intact material, the impactor residue in #31 was completely melted (Figs. 5 and 6). The impactor appears to have melted on impact, thus, lining the crater bottom and walls with glassy impact melt. Twisted glass is present in the bottom where the morphology suggests freezing of viscous, molten material during splash rebound after impact. Small glassy beads line the upper walls of the crater (Fig. 6). Even though the impactor appears to have completely melted, a "chondritic" compositional signature remains together with a rather large amount of carbon, at least on the residue surface (see the next section).

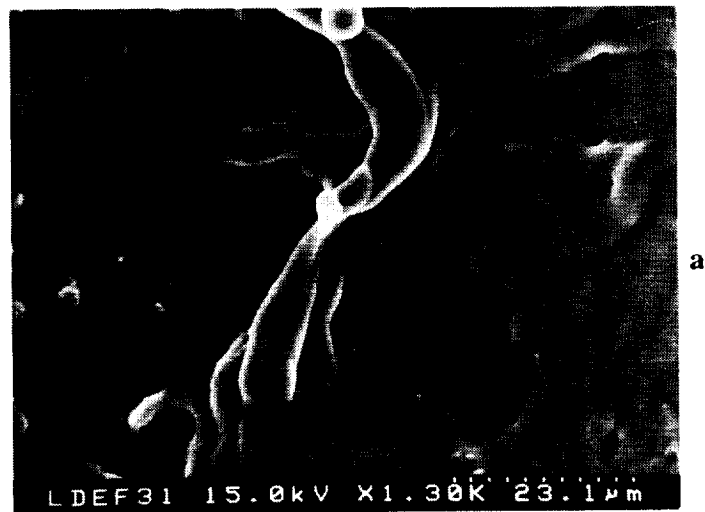
Figure 6. (a) Enlarged view of crater bottom glassy impactor debris which is mixed with melted Al. (b) Small glassy droplets near the top of the crater wall. The light droplets may be metal or sulfides. (FESEM BSE image).
